# AVONBANK MINERAL SANDS PROJECT

## MINE REHABILITATION

### Factsheet

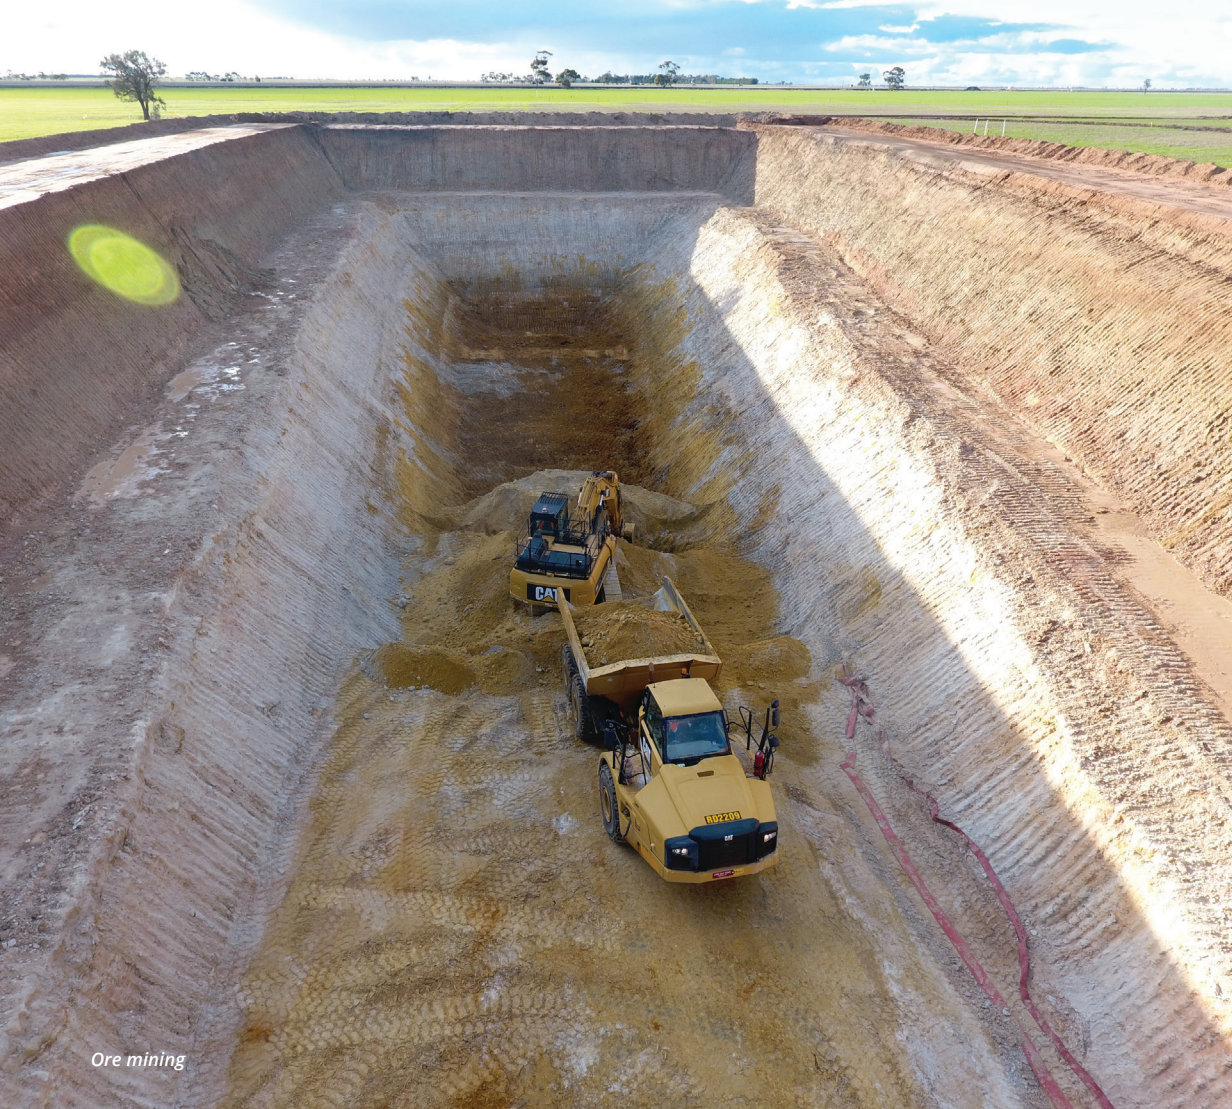
Ore mining

Following removal and stockpiling of the soils and overburden, ore was excavated and trucked to the pilot plant for processing.

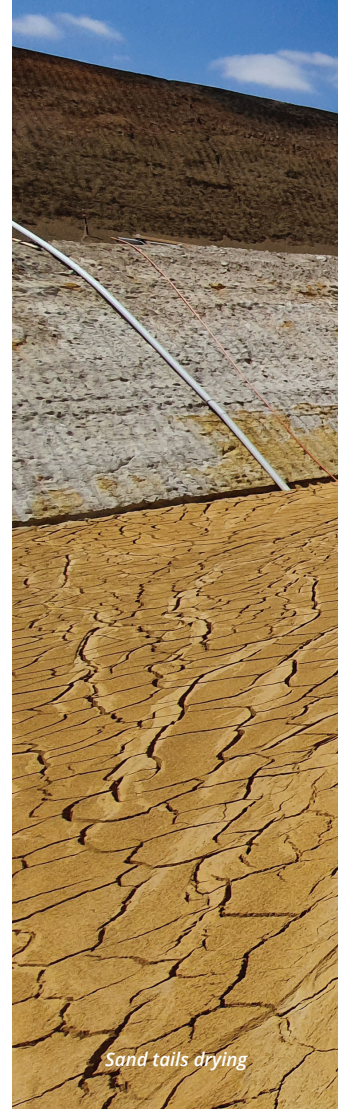
Sand tails drying

In-pit tails were left to consolidate for around 9 months. Geotechnical testing was undertaken

to demonstrate that the tails had consolidated sufficiently. Following tails consolidation, overburden was placed followed by placement of the subsoils and topsoil.

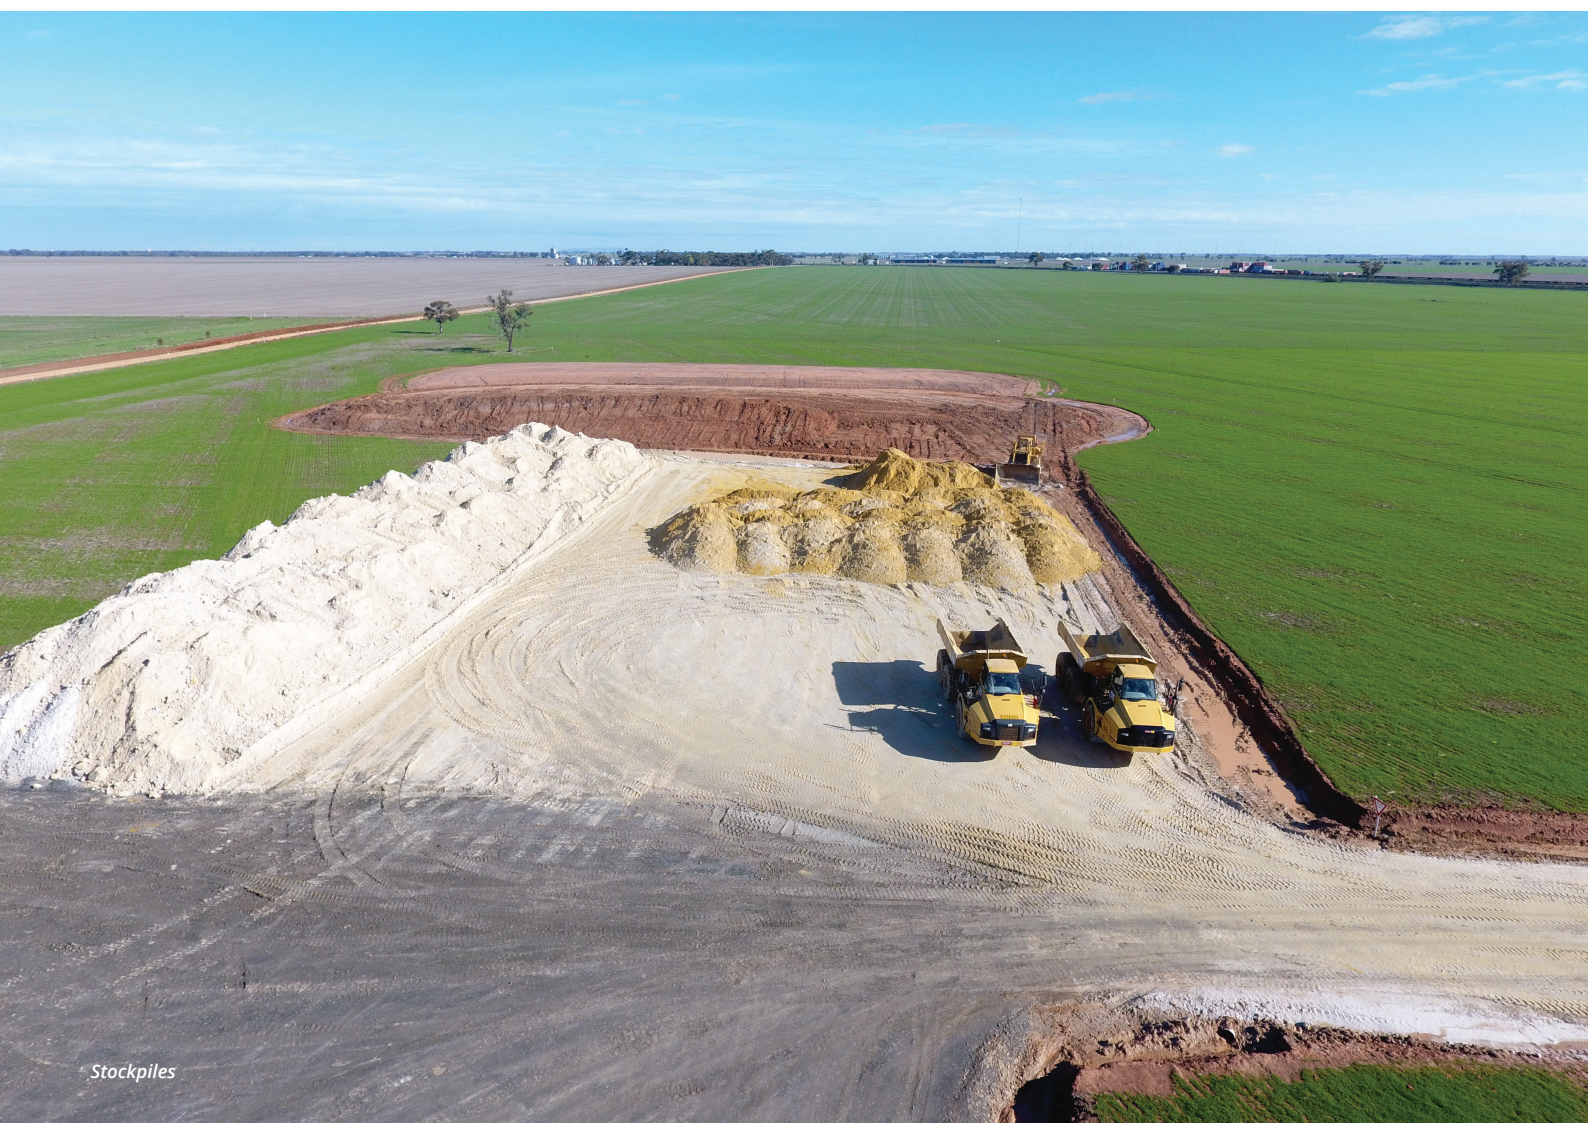
Stockpiles

Following the soil surveys, topsoil and subsoils were stripped and three separate stockpiles were established for topsoil, upper and lower subsoil units and a fourth stockpile was established for excavated overburden.

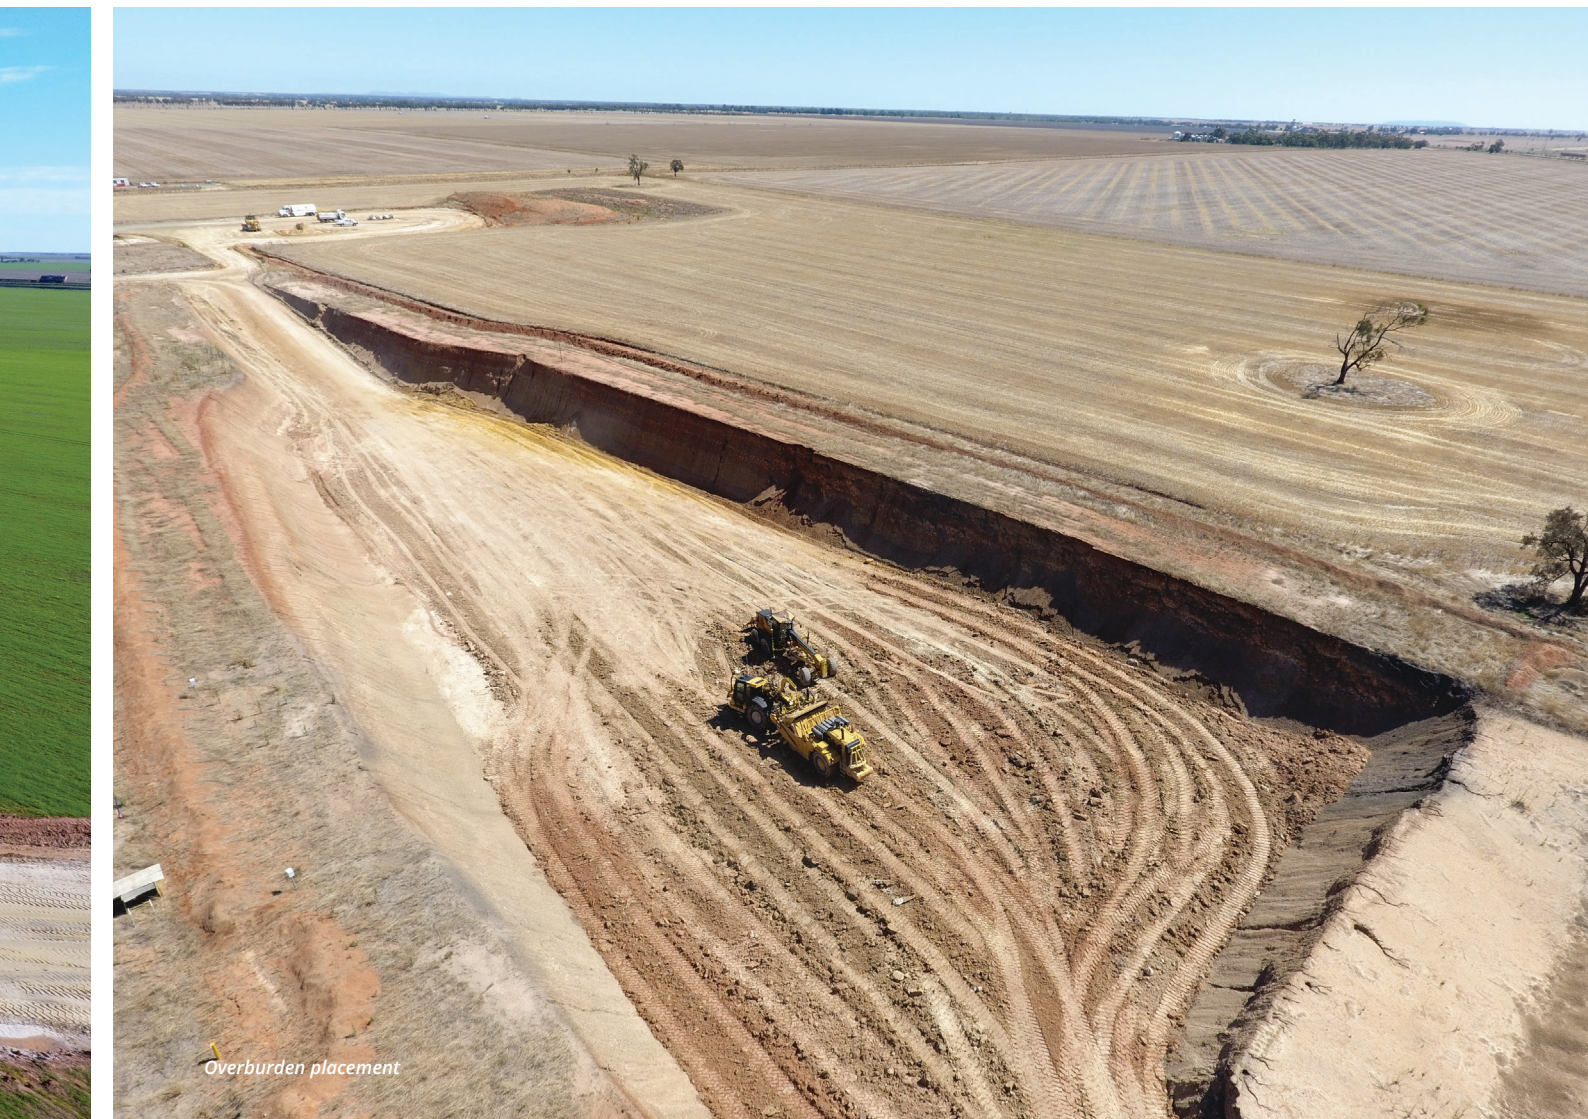
Overburden placement

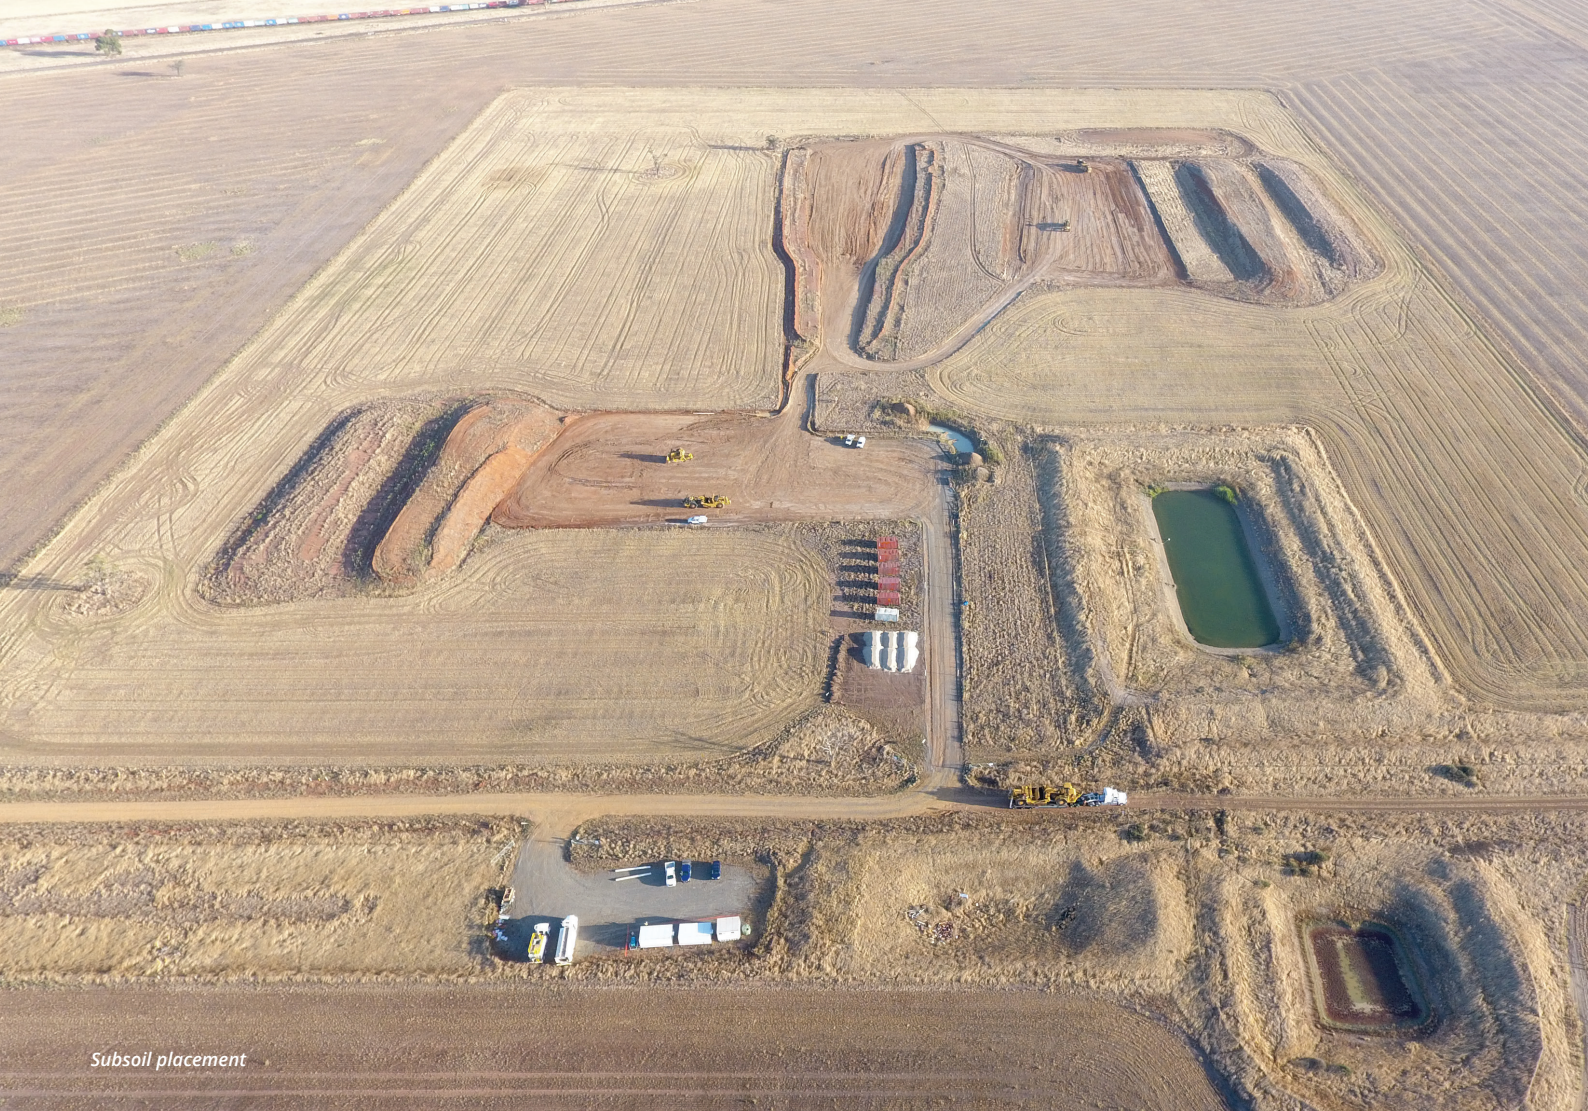
*Subsoil placement*

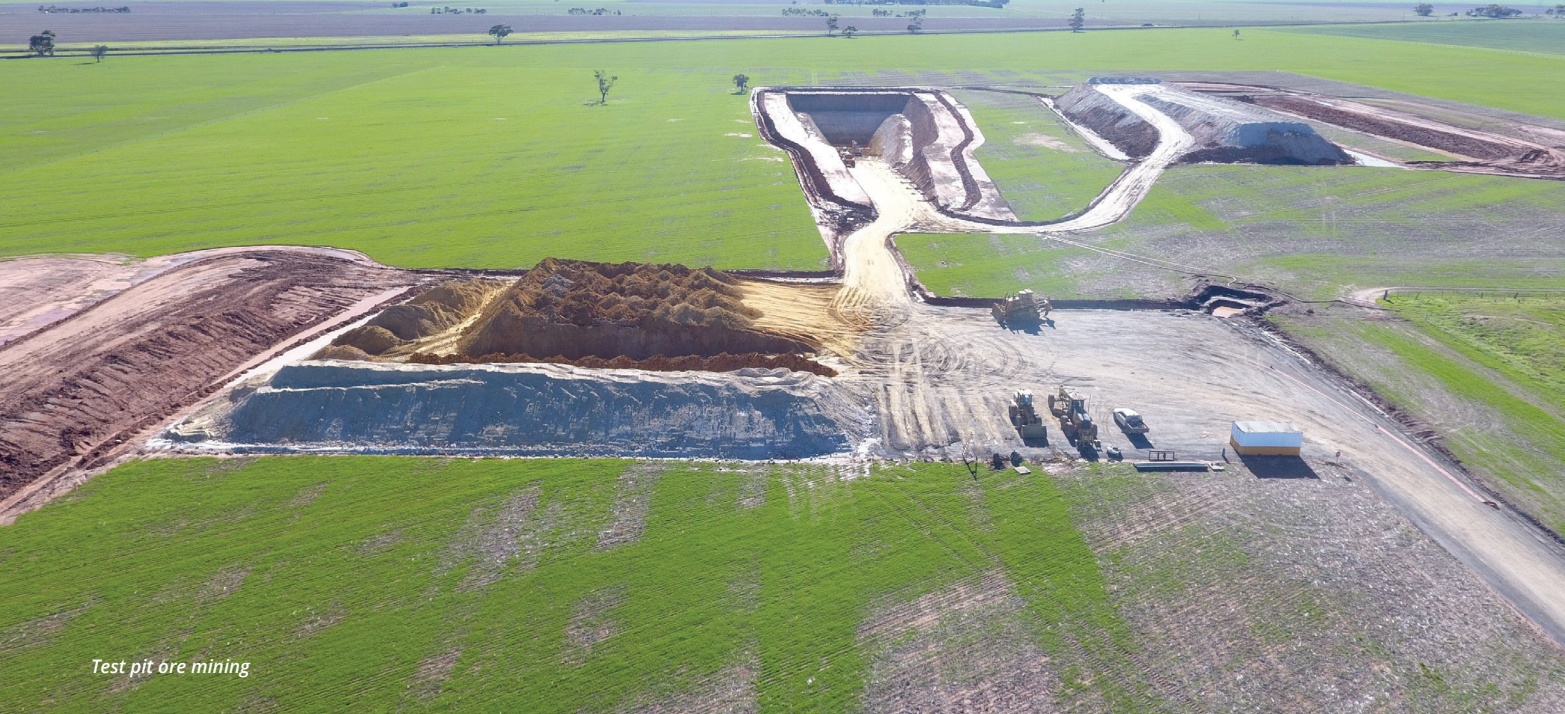
*Test pit ore mining*

- Excavation of a test pit and removal of over 11,000 tonnes of ore
- Construction of a Demonstration Scale Wet Concentration Plant (WCP) at site
- Processing of ore through the WCP over a period of six months to produce a high-quality Heavy Mineral Concentrate (HMC)
- Rehabilitation of the test pit back to a cropping land use and on going monitoring

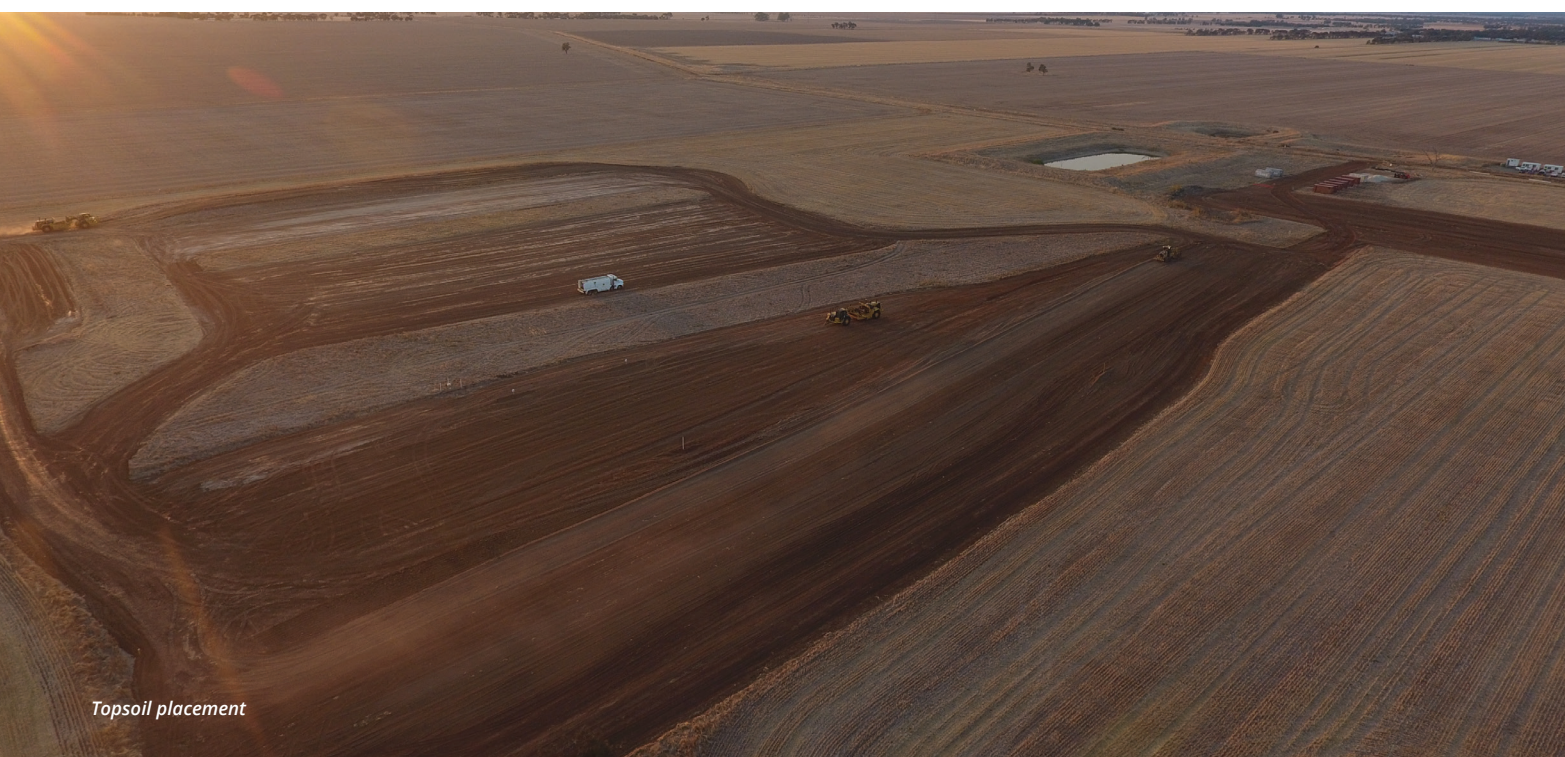
*Topsoil placement*

Following topsoil placement, the area was seeded with barley in 2021, lentils in 2022 and wheat in 2023.

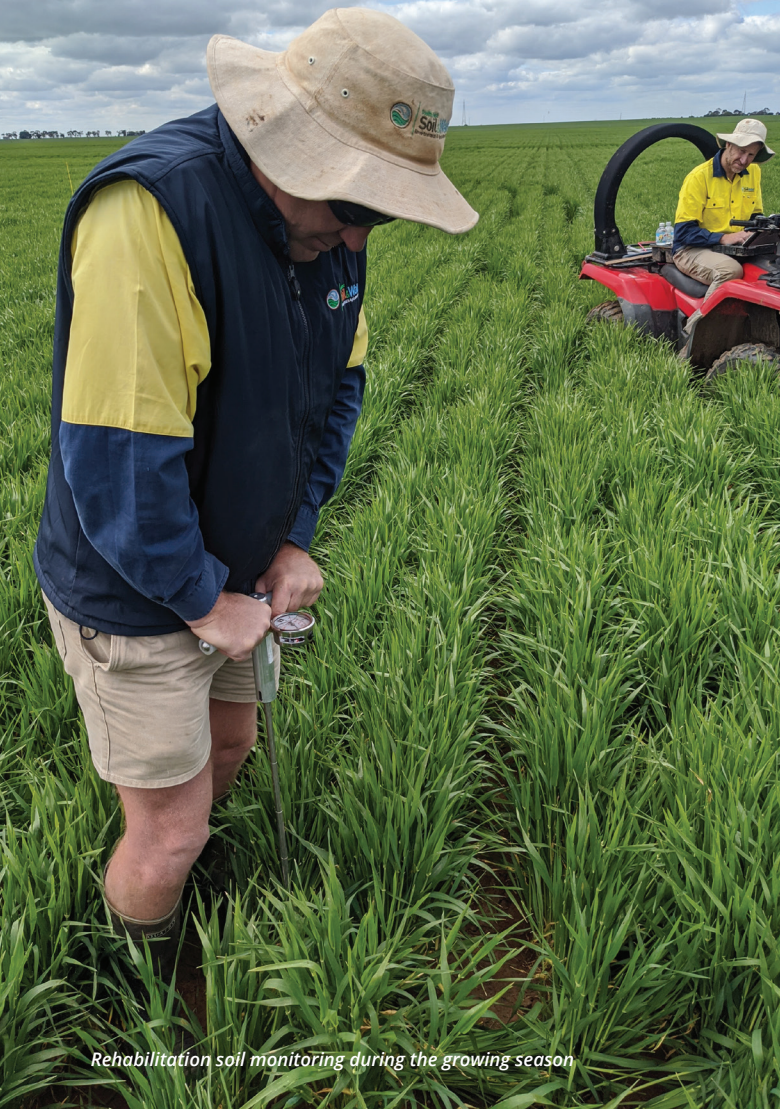
*Rehabilitation soil monitoring during the growing season*

Rehabilitation monitoring was conducted during each growing season.

The site showed no material evidence of ground movement or erosion, and the estimated crop yield monitored through each growing season were similar or higher in the rehabilitated site than the unmined areas in 2021 and 2022.

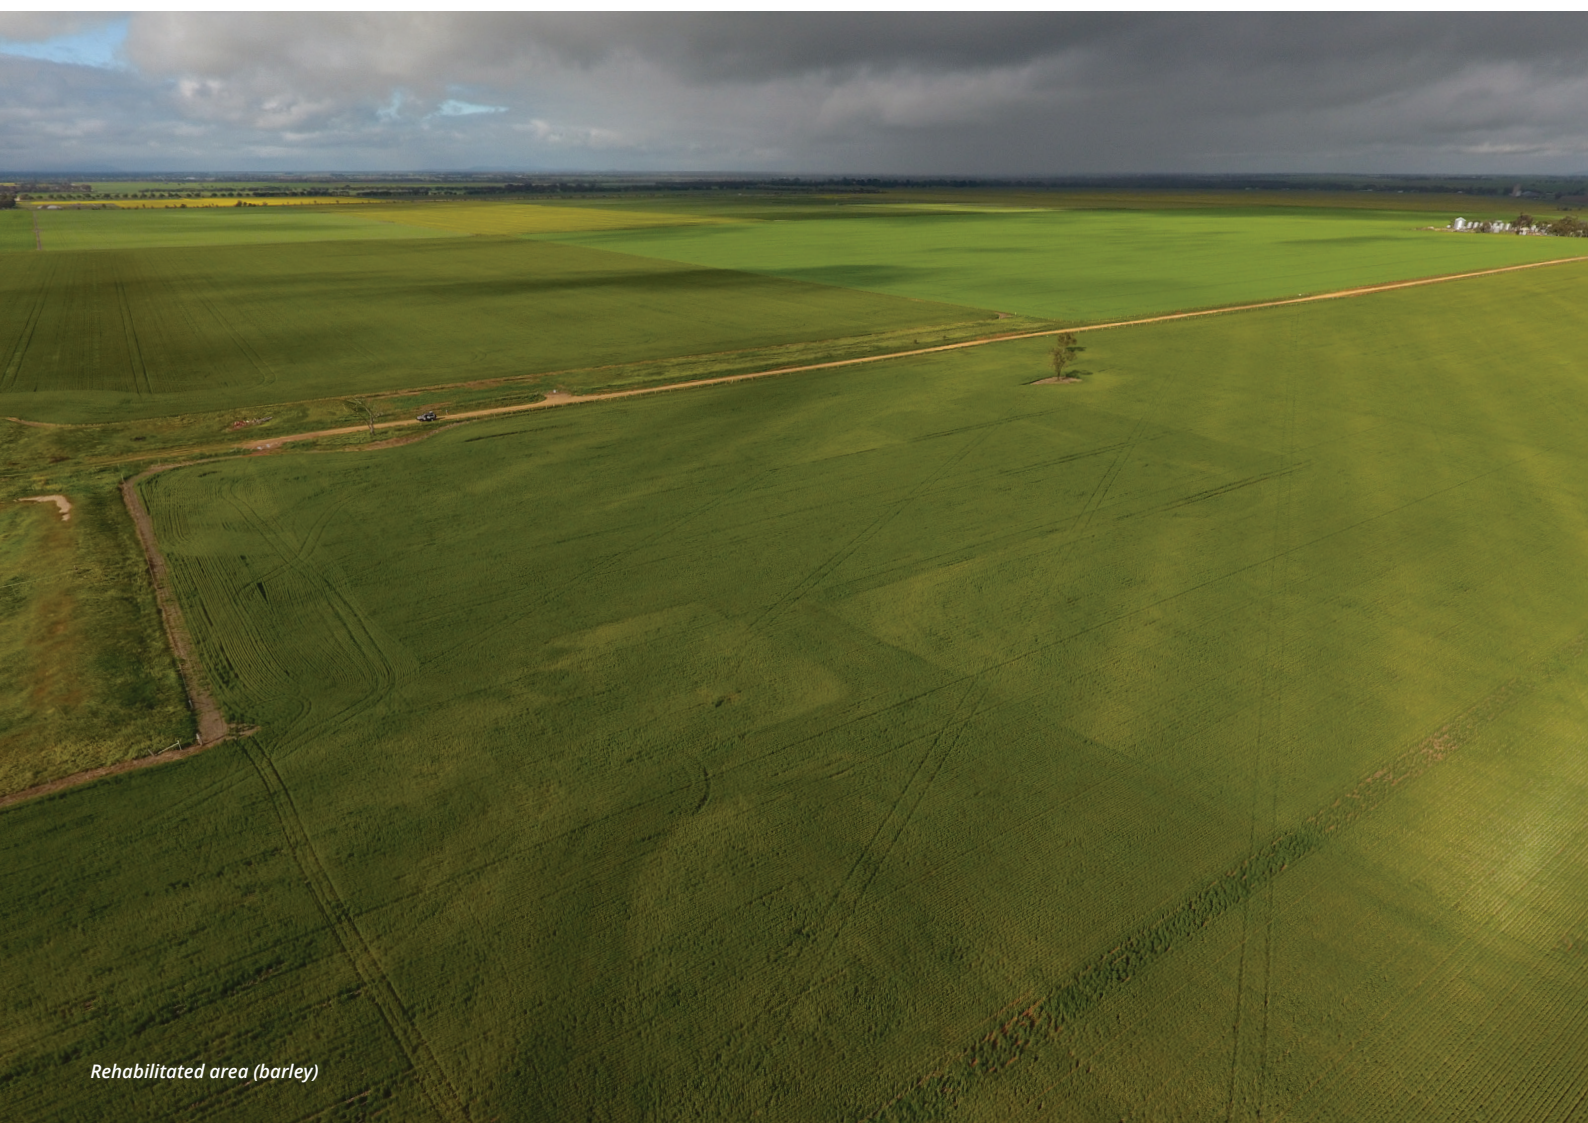
*Rehabilitated area (barley)*
